# NOORIJAM TAMACHI

PLAN  
NOORI JAMTAMACHI TOND  
RESTORATION PROPOSAL

**NOORIJAM TAMACHI**  
**Restoration Proposals**

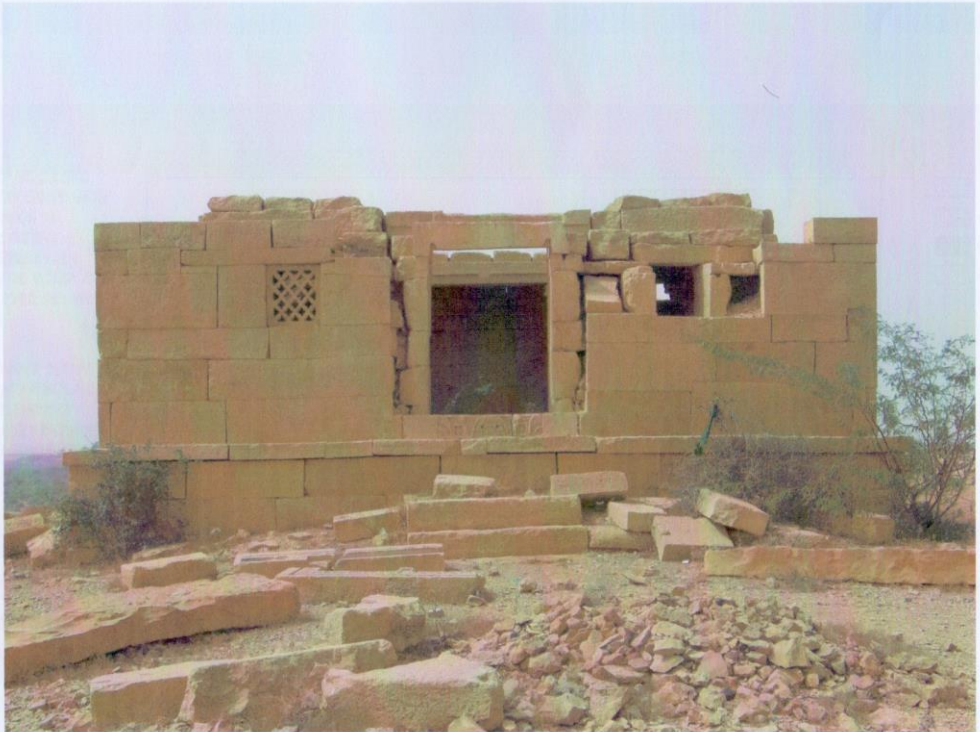
FRONT ELEVATION

MASONRY WALL IS LARGELY INTACT, BUT HAS  
 DEVELOPED GAPS AND CAVITIES AT A FEW PLACES,  
 WHICH HAVE RESULTED FROM SETTLEMENT OF  
 FOUNDATION. ANOTHER REASON FOR THE CAVITIES AND  
 GAPS IN THE MASONRY IN THE RAIN WATER PENETRATION  
 TO DAMAGED CORNICE.

THE PARTS OF THE WALL WHICH ARE BULGING  
 IT OR HAVE ALREADY FALLEN OFF CAN BE TAKEN  
 IT AND THEN AFTER CONSOLIDATION THE  
 JOINING AREAS THESE MAY BE PUT BACK TO  
 THEIR EXACT LOCATIONS AGAIN. SOME FALLEN  
 PIECES MAY BE FOUND LYING IN THE VICINITY AND  
 IF THEIR LOCATION IS ESTABLISHED THEY MAY  
 BE PUT BACK IN PLACE.

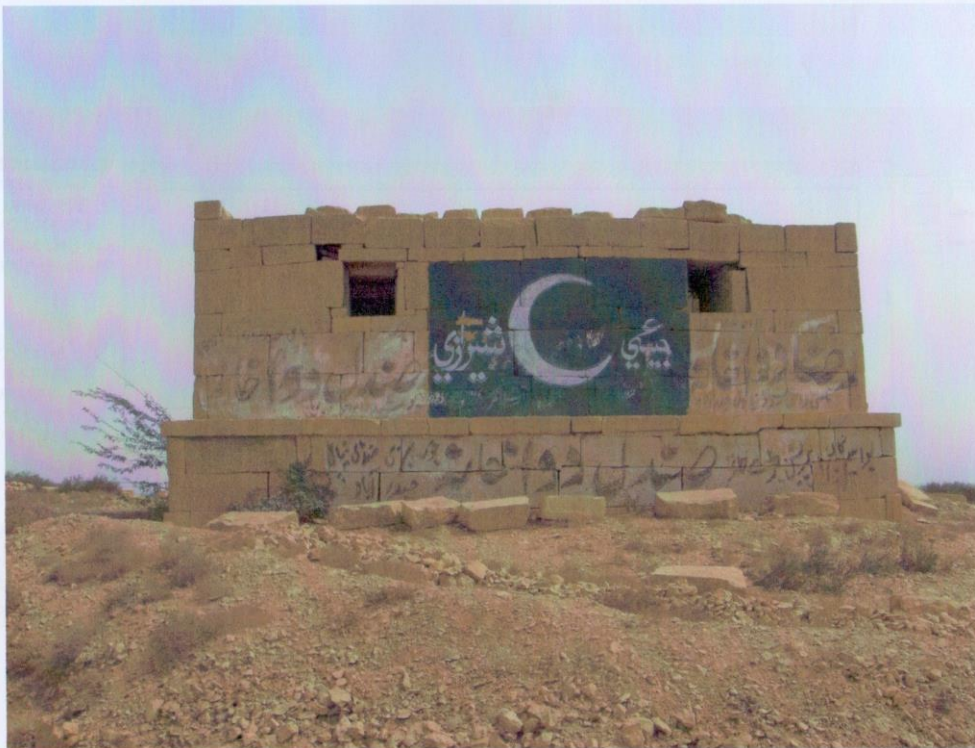
REAR ELEVATION

MASONRY WALL IS LARGELY INTACT, BUT HAS  
 SLOPED GAPS AND CAVITIES AT A FEW PLACES,  
 1) WHICH HAVE RESULTED FROM SETTLEMENT OF  
 FOUNDATION. ANOTHER REASON FOR THE CAVITIES AND  
 2) GAPS IN THE MASONRY IS THE RAIN WATER PENETRATION  
 TO DAMAGED CORNICE.

THE PARTS OF THE WALL WHICH ARE BULGING OUT OR  
 1) ALREADY FALLEN OFF CAN BE TAKEN OUT AND  
 2) AFTER CONSOLIDATION THE ADJOINING AREAS  
 3) MAY BE PUT BACK TO THEIR EXACT LOCATIONS  
 4) IN SOME FALLEN PIECES MAY BE FOUND LYING IN  
 VICINITY AND ONES THEIR LOCATION IS ESTABLISHED  
 5) MAY BE PUT BACK IN PLACE.

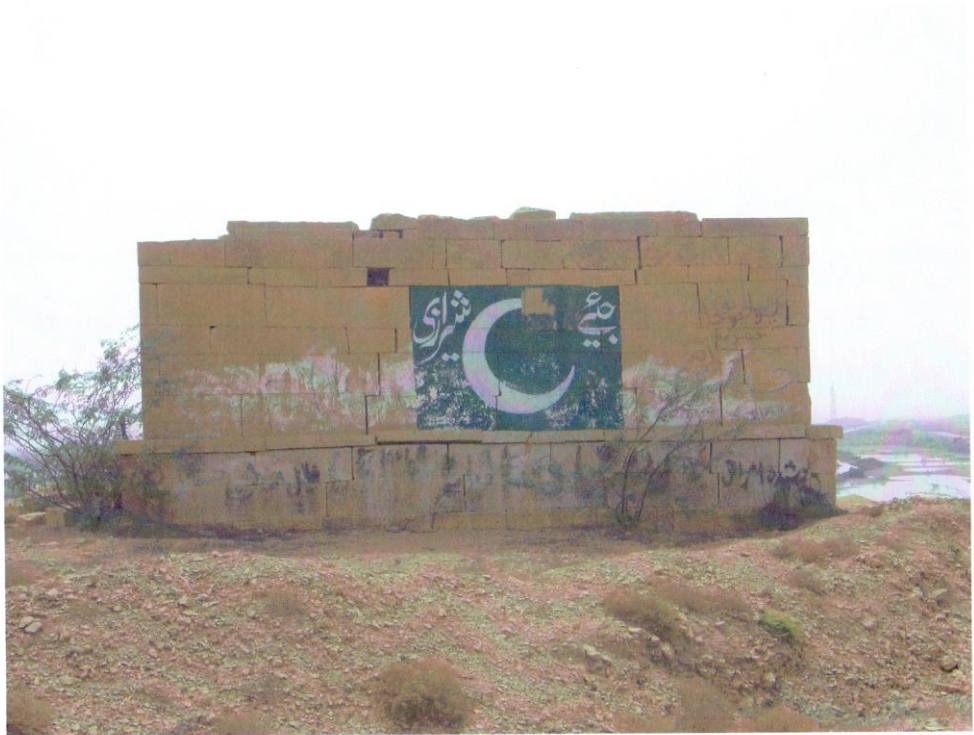
**RIGHT SIDE ELEVATION**

MASONRY WALL IS LARGELY INTACT, BUT HAS  
 DEVELOPED GAPS AND CAVITIES AT A FEW PLACES,  
 WHICH HAVE RESULTED FROM SETTLEMENT OF  
 FOUNDATION. ANOTHER REASON FOR THE CAVITIES AND  
 GAPS IN THE MASONRY IS THE RAIN WATER PENETRATION  
 INTO THE DAMAGED CORNICE.

THE PARTS OF THE WALL WHICH ARE BULGING OUT OR  
 HAVE ALREADY FALLEN OFF CAN BE TAKEN OUT AND  
 THEN AFTER CONSOLIDATION THE ADJOINING AREAS  
 CAN BE PUT BACK TO THEIR EXACT LOCATIONS  
 AND SOME FALLEN PIECES MAY BE FOUND LYING IN  
 THE VICINITY AND ONES THEIR LOCATION IS ESTABLISHED  
 THEY MAY BE PUT BACK IN PLACE.

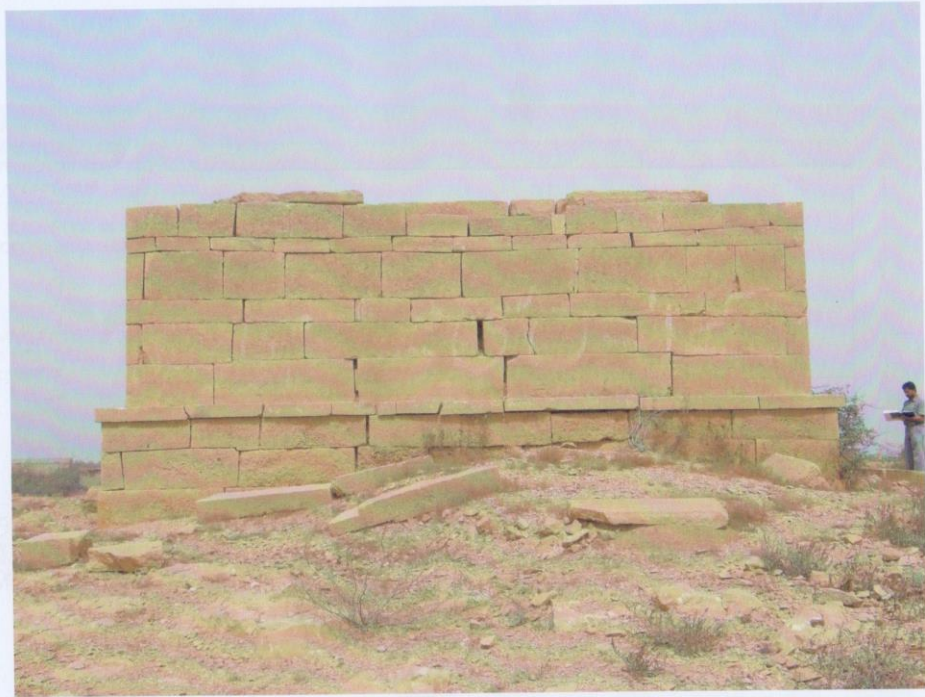
**LEFT SIDE ELEVATION**

MASONRY WALL IS LARGELY INTACT, BUT HAS  
 BULGED GAPS AND CAVITIES AT A FEW PLACES,  
 WHICH HAVE RESULTED FROM SETTLEMENT OF  
 FOUNDATION. ANOTHER REASON FOR THE CAVITIES AND  
 GAPS IN THE MASONRY IS THE RAIN WATER PENETRATION  
 THROUGH THE DAMAGED CORNICE.

THE PARTS OF THE WALL WHICH ARE BULGING OUT OR  
 ALREADY FALLEN OFF CAN BE TAKEN OUT AND  
 AFTER CONSOLIDATION THE ADJOINING AREAS  
 MAY BE PUT BACK TO THEIR EXACT LOCATIONS  
 IN SOME FALLEN PIECES MAY BE FOUND LYING IN  
 VICINITY AND ONES THEIR LOCATION IS ESTABLISHED  
 THEY MAY BE PUT BACK IN PLACE.
